AMERICAN AIRLINES, INC.
BOEING 727, N1996
NEAR THE GREATER CINCINNATI AIRPORT
CONSTANCE, KENTUCKY
NOVEMBER 8, 1965

CIVIL AERONAUTICS BOARD

AIRCRAFT ACCIDENT REPORT

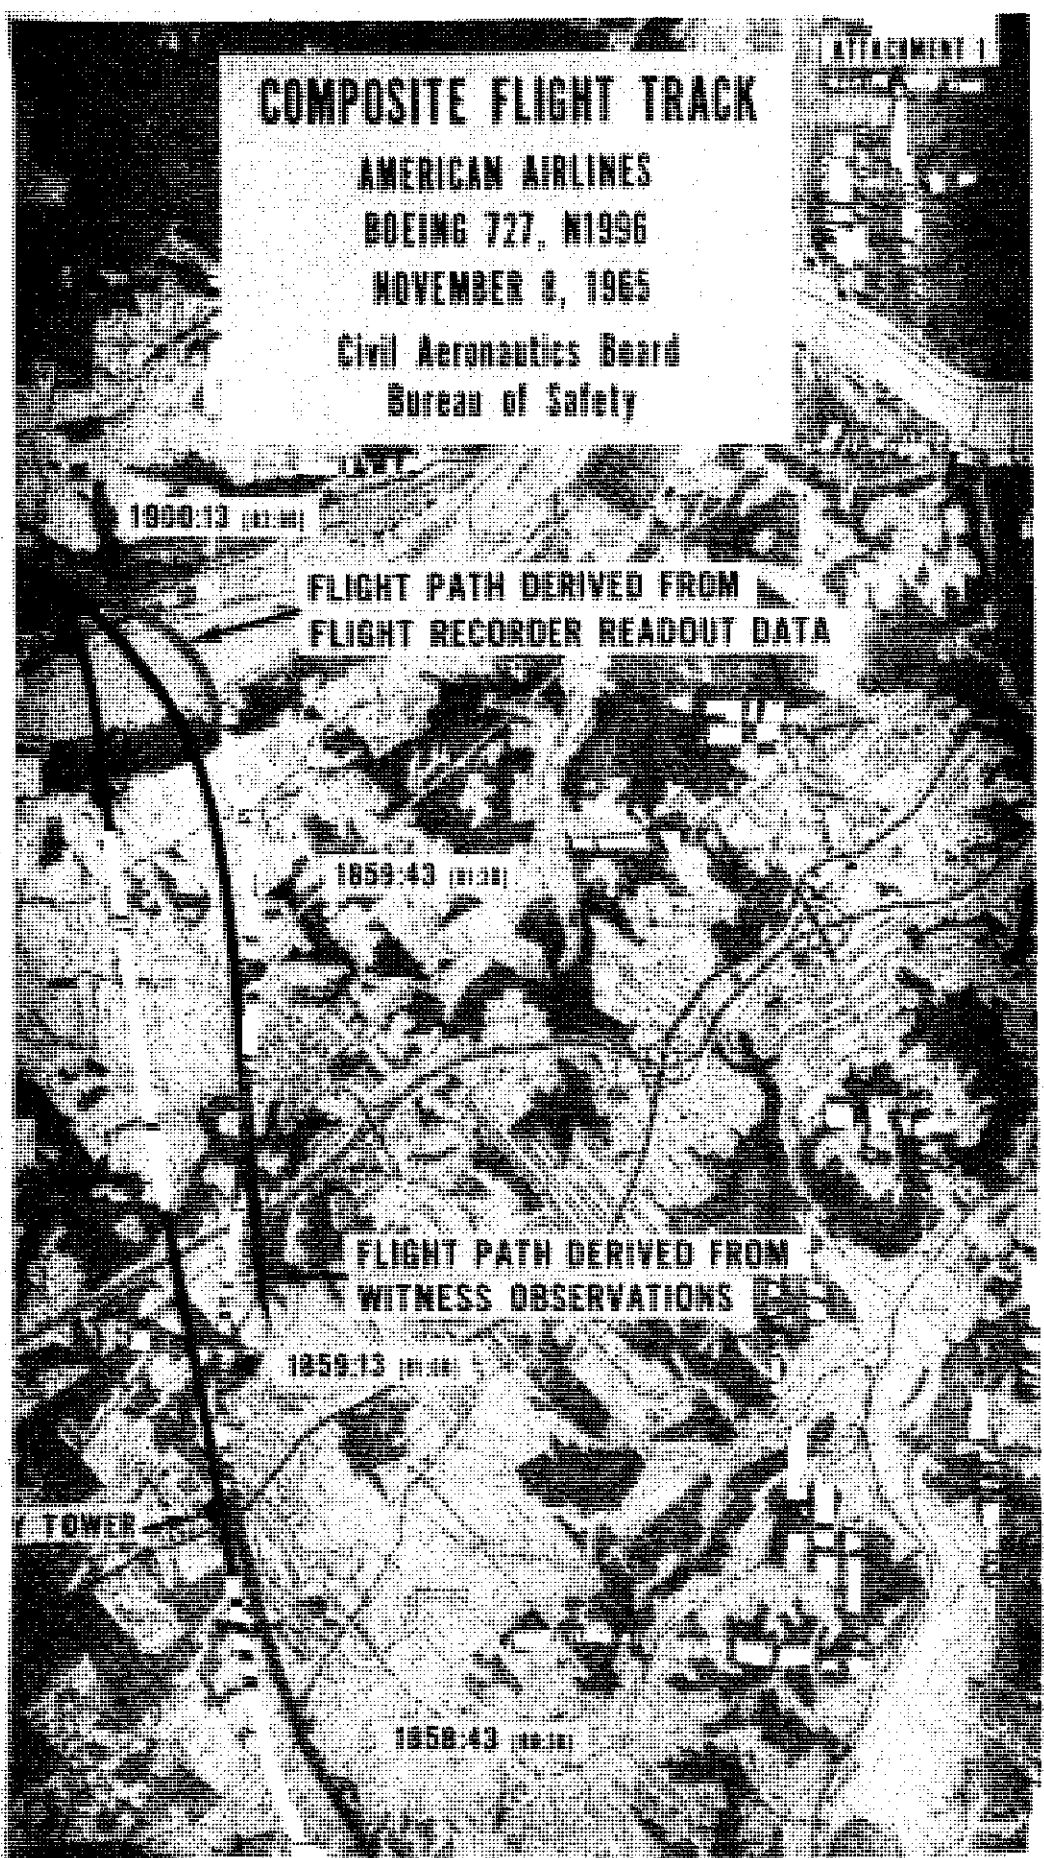
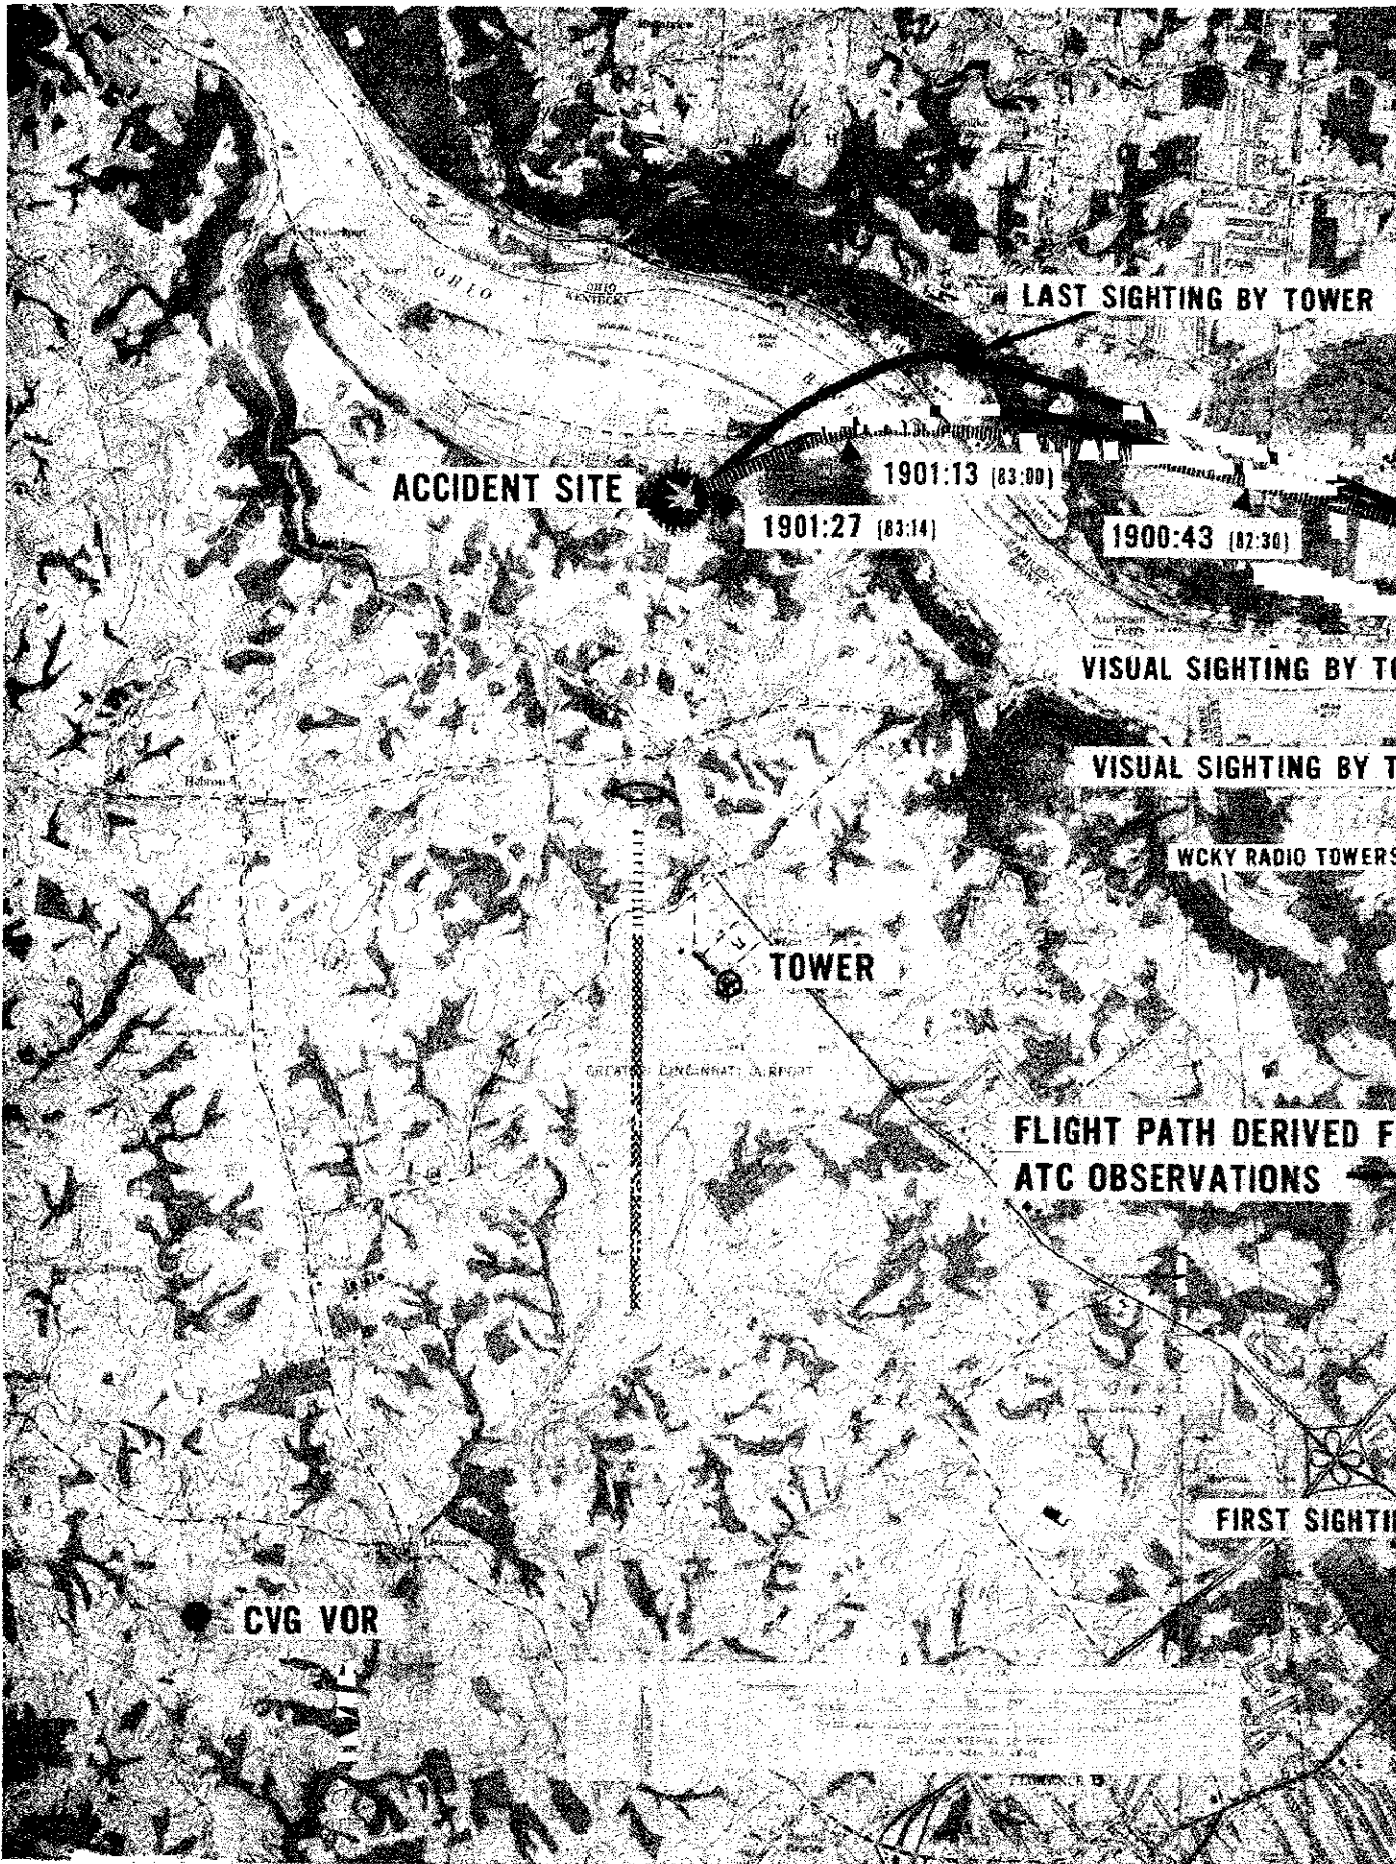
Federal Aviation Agency (FAA) tower personnel first observed the aircraft at a point approximately four miles east-southeast of the airport as it proceeded on the downwind leg in a northerly direction. (See Attachment #1.) It was stated that the aircraft's navigation lights were clearly visible and that the flight appeared to be operating at a normal traffic pattern altitude. One of the controllers stated that the aircraft passed about one mile to the east of the WCKY radio towers (located three miles east-northeast of the control tower), then commenced a left turn onto the base leg and started a gradual descent. The controller continued to watch the aircraft as it proceeded west on the base leg; however, at a point between two and three miles northeast of the airport it disappeared from his view. He stated that he believed the aircraft was lost from his view because it, ". . . appeared to fly into or behind weather phenomena."

A number of persons on the ground observed the aircraft during its approach. Their observations placed the aircraft approximately four miles east of the field on a northerly course while on the downwind leg. (See Attachment #1.) The flight was observed as it crossed the Ohio River and turned left to a westerly course. Witnesses stated that the aircraft had its navigation and landing lights on and that its altitude appeared to be low at this point.

It is noted that the particular terrain (see Attachment #1) in the vicinity of the aircraft's flightpath may well have provided the crew with an illusion of proper altitude or adequate terrain clearance. The Ohio River basin directly to the left of the flightpath is approximately 400 feet lower than the terrain directly under or to the right of the aircraft's flightpath. Also the terrain south of the river in the direction of the airport is featured by a wooded unlighted hillside which rises steeply from the river to the approximate elevation of the airport. Except for the lights of residences located near the riverbank there are no lights which would provide terrain definition. At night under poor visibility conditions it is quite conceivable that the elevation of the lights in the river valley could be associated with the elevation of the terrain in the vicinity of the airport.

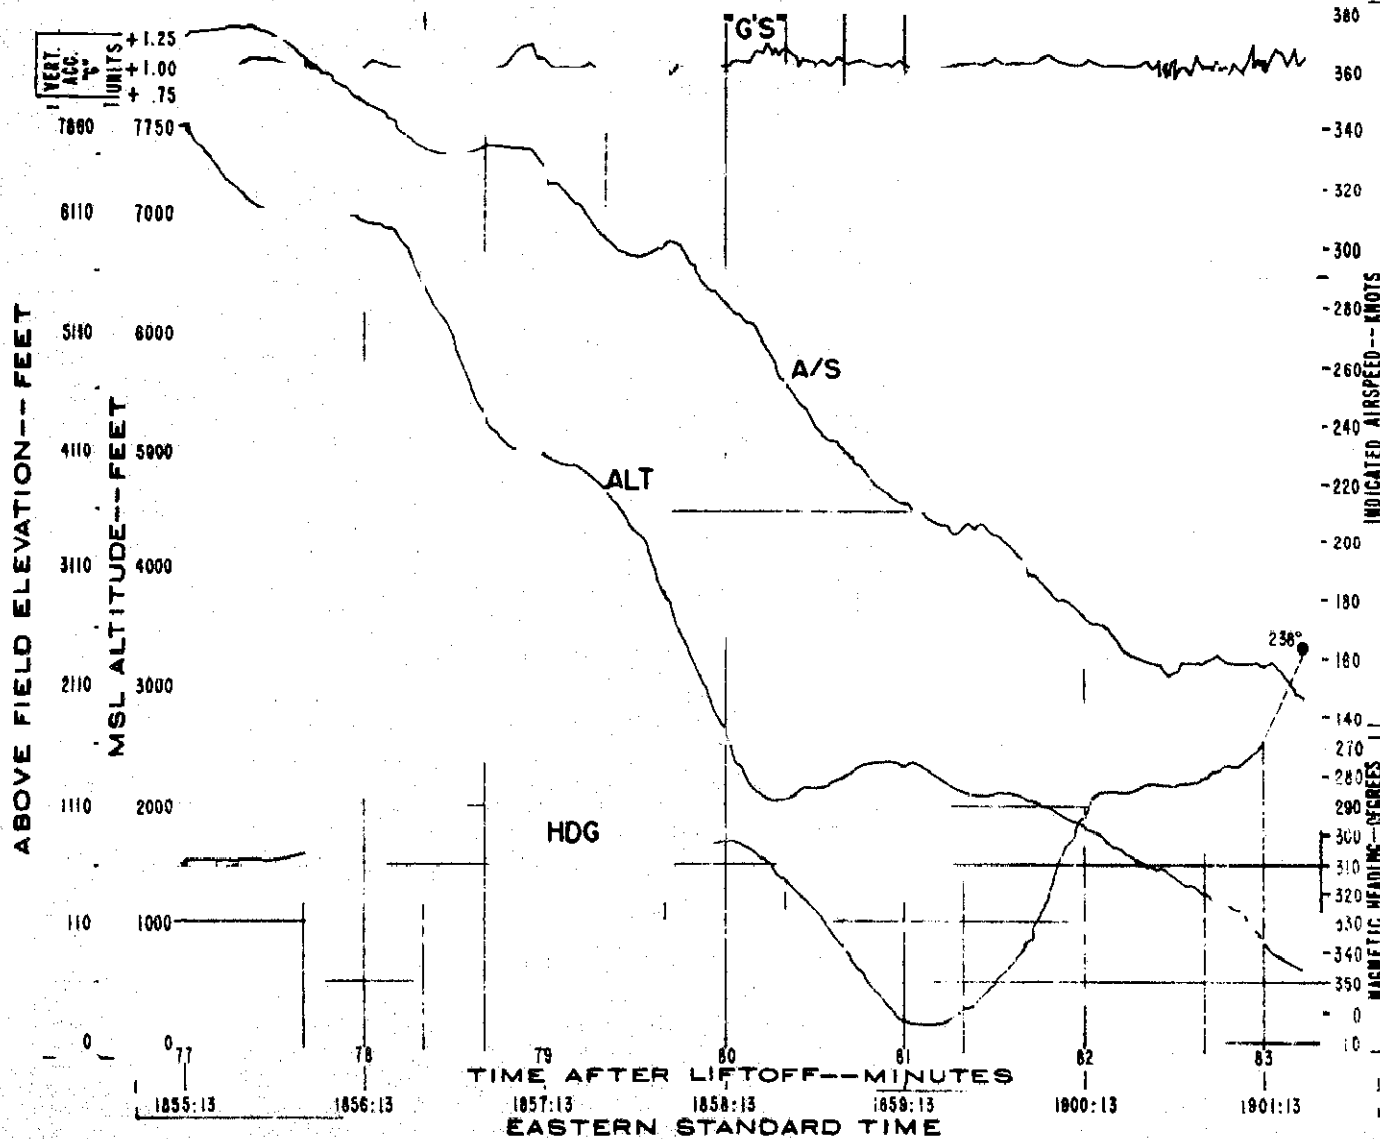
FLIGHT RECORDER DATA GRAPH
UDC MODEL F542 S/N 1395

The acceleration excursions noted throughout the readout were consistent with the maneuvers being performed and, except for the last 50 seconds of flight, no significant turbulence activity was noted. During the last 50 seconds of flight the G trace activity was suggestive of light turbulence computed to be less than 14 feet per second.

Note. Heading Parameter unreliable beyond 82.59 minutes due to aberrant area on tape except for data point at 83:14. Trace shown dotted between last readable points.

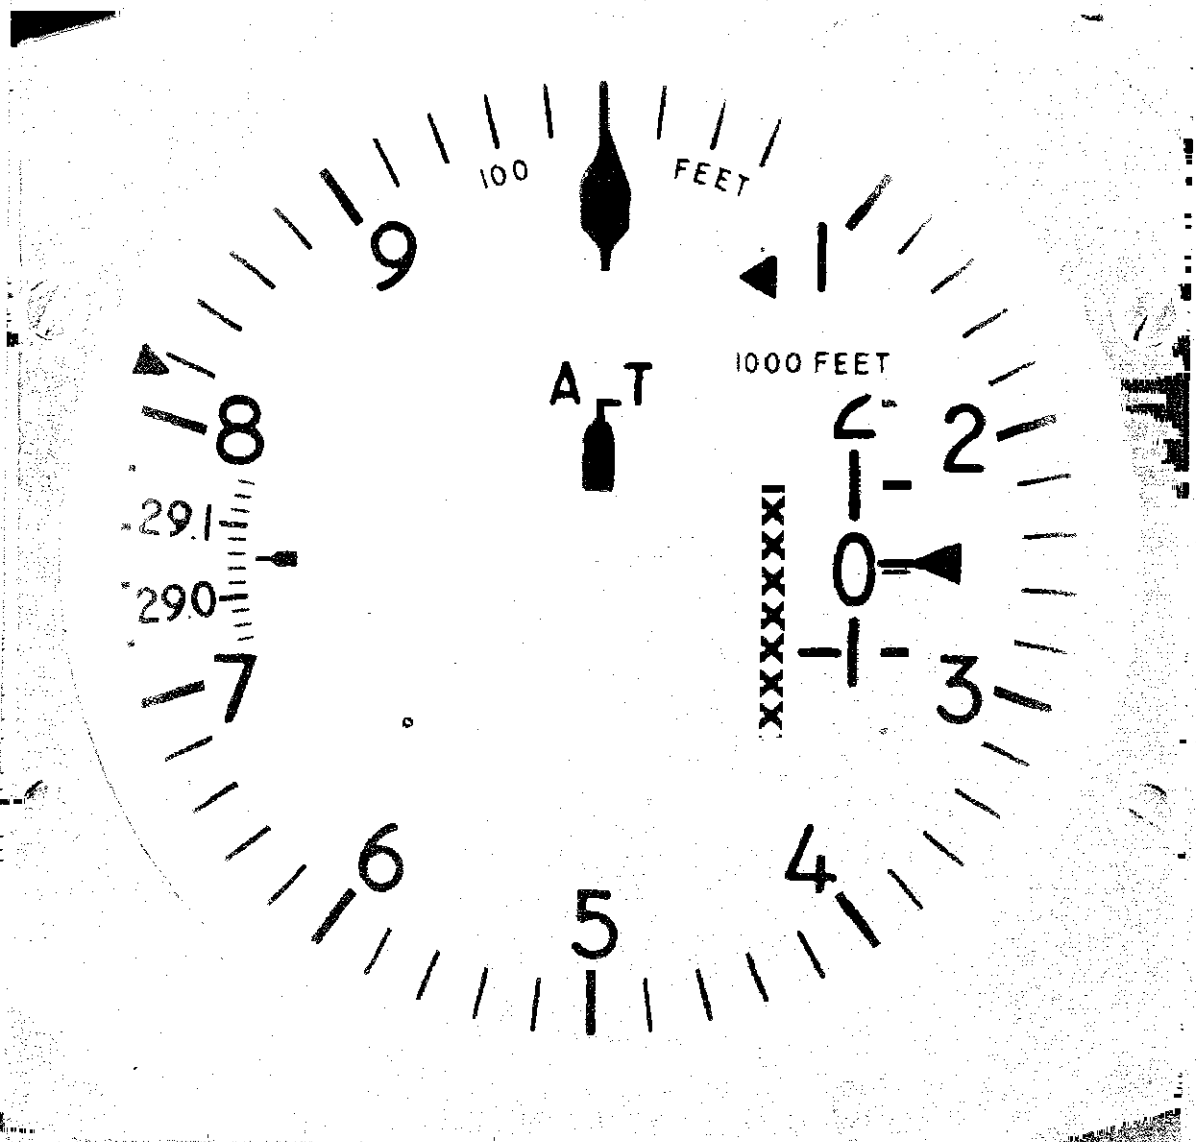
KOLLSMAN ALTIMETER

The three Kollsman altimeters^{9/} installed in the aircraft were recovered from the wreckage and were examined at the manufacturer's facility. The captain's (No. 1) altimeter was found at a barometric setting of 29.06 inches with the index marker set on 800 feet. A valid drum position could not be obtained because of internal mechanism disruption. The copilot's (No. 2) altimeter was found at a barometric scale setting of 29.03 inches with the index marker positioned at 815 feet. Only portions of the center instrument panel (No. 3) altimeter were recovered and no barometric, index marker, or drum position information could be obtained. A discussion of the American Airlines procedures for altimeter utilization and related procedures will be found in section 1.15 under the heading of AA altimeter procedures.

It is realized that in these cases or in any altitude presentation a pilot knowledgeable in the altimeter should have no problem whatsoever in quickly determining the correct altitude reading. However, it can also be seen that under certain conditions compounded by infrequent, fragmented, or distracted monitoring, a misreading/misinterpretation of altitude could occur.

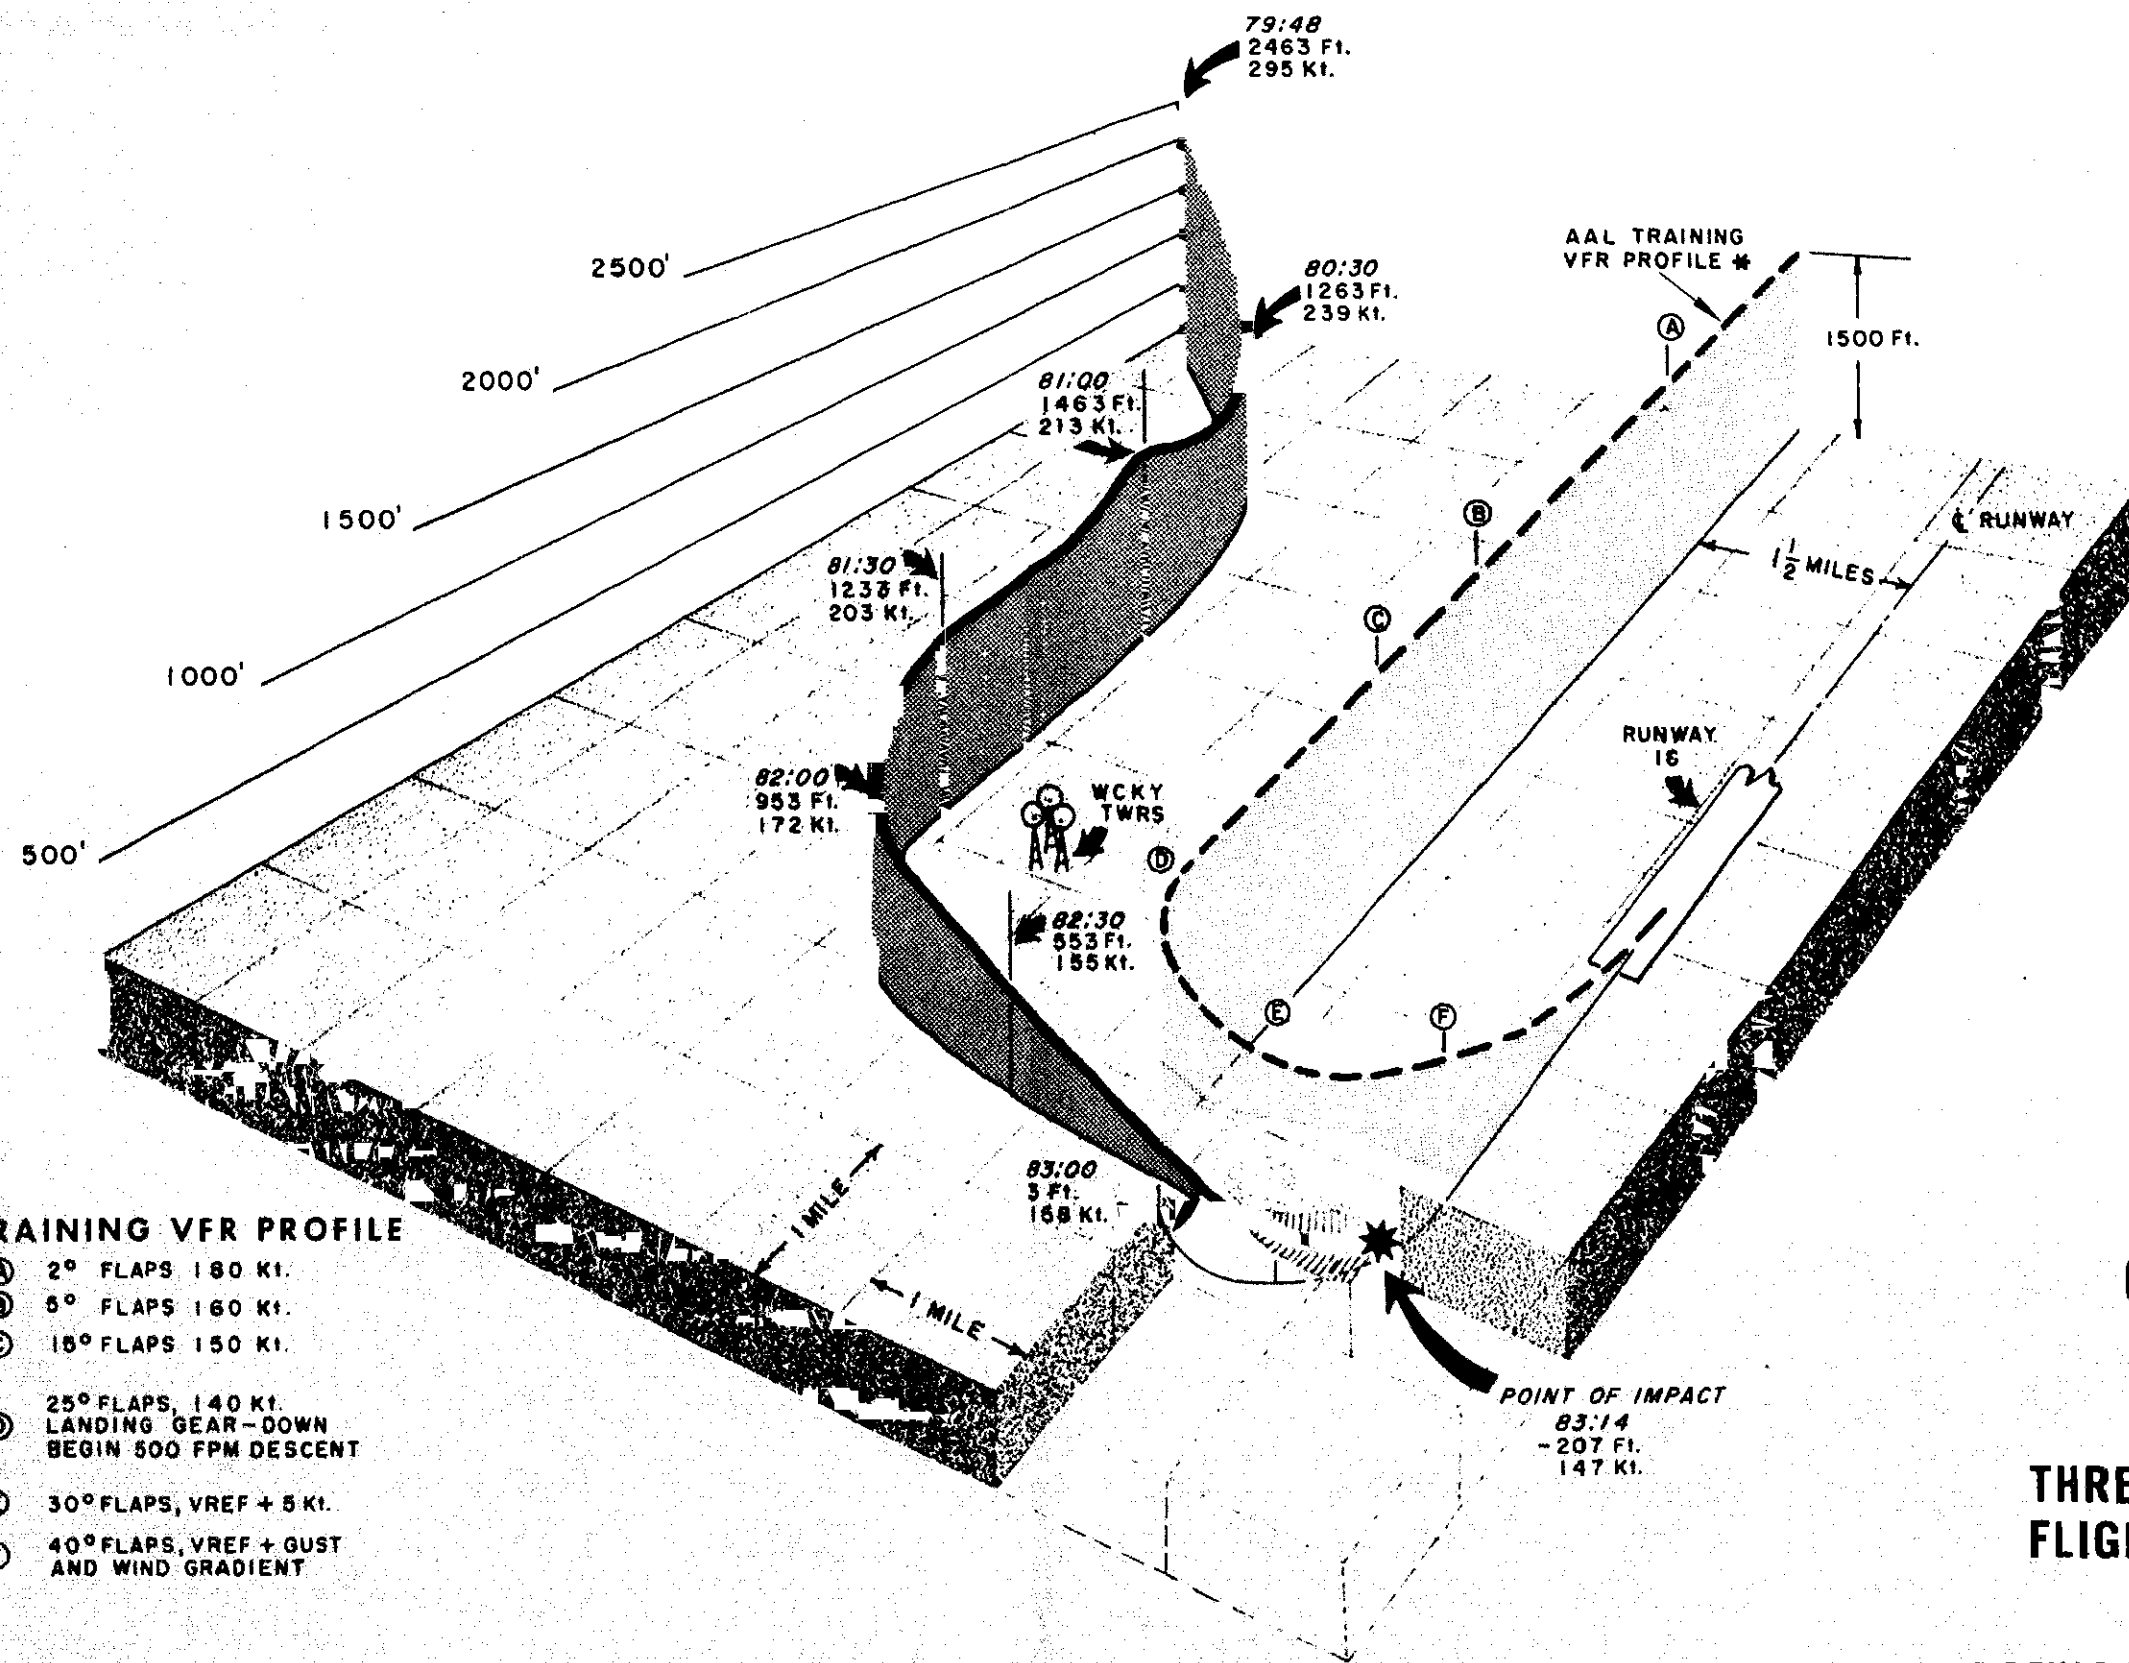
AAL TRAINING VFR PROFILE

Examination of the AA 727 flight training curriculum disclosed that the normal VFR (training) pattern for Boeing 727 type aircraft (see Attachment #3) calls for the downwind leg to be flown at a distance of 1-1/2 miles out from the runway. Since the flight recorder, ATC observations, and witness observed flightpaths all indicate that the downwind leg on this flight was flown at a distance of 4-1/2 miles from runway 18, this aspect of the approach was explored in detail. Testimony from AA training and operations representatives at the public hearing indicated that although the VFR training pattern taught to pilots in the training syllabus serves as the standard or desired VFR approach, many variances of this pattern can be, and are, utilized in actual line operations. It was stated that the variables in the VFR

The traffic pattern airspeeds and aircraft configuration sequences utilized by N1996 were compared to appropriate airspeeds and recommended configuration sequences outlined in the VFR training pattern. From this study it was indicated that the various flap extensions during the approach conformed with the AA normal operating extension speeds. However, because of the comparatively higher airspeeds maintained by the flight throughout the approach, these flap extensions were concentrated or "bunched-up" on the base leg.
