## KENTUCKY HISTORIC RESOURCES INVENTORY

<b>1. Name of Site:</b> Stone house on Bracken Creek		<b>16. Date:</b> early 19th century	[ 2 ]
<b>2. Prehistoric Site</b>	<b>Building</b> <input checked="" type="checkbox"/>	<b>Object</b>	[ ]
<b>Historic Site</b>	<b>Structure</b>	<b>Other</b>	
<b>3. Location:</b> North side of Bracken Creek off KY 435, two miles east of KY 8, <i>near Augusta</i>		<b>17. Style:</b> Federal	[ B ]
<b>4. ADD/County:</b> Buffalo Trace/Bracken [012]		<b>18. Architect/Builder:</b>	[ ]
<b>5. Original Owner:</b> Not Known		<b>19. No. of Stories:</b> two plus cellar & attic	[ C ]
<b>6. Other Names:</b>		<b>20. Original Floor Plan:</b> Central passage	[ I ]
<b>7. Owners Name:</b> Roy Collins		<b>21. Single Pile</b>	<b>Double Pile</b> <input checked="" type="checkbox"/>
<b>8. Owners Address:</b> Route #1 Augusta, Kentucky 41002		<b>22. Roof Form &amp; Original Material:</b> Gable	<b>N.A.</b>
<b>9. Evaluation:</b> Meets National Register [ D ]		<b>23. Structural Material:</b> Stone	[ B ]

1. Name of Resource:  
Stone House on Bracken Creek

Stone House on Bracken Creek (Early Stone  
Buildings of Kentucky--Outer Bluegrass and  
Pennyrite TR)  
Bracken County  
KENTUCKY

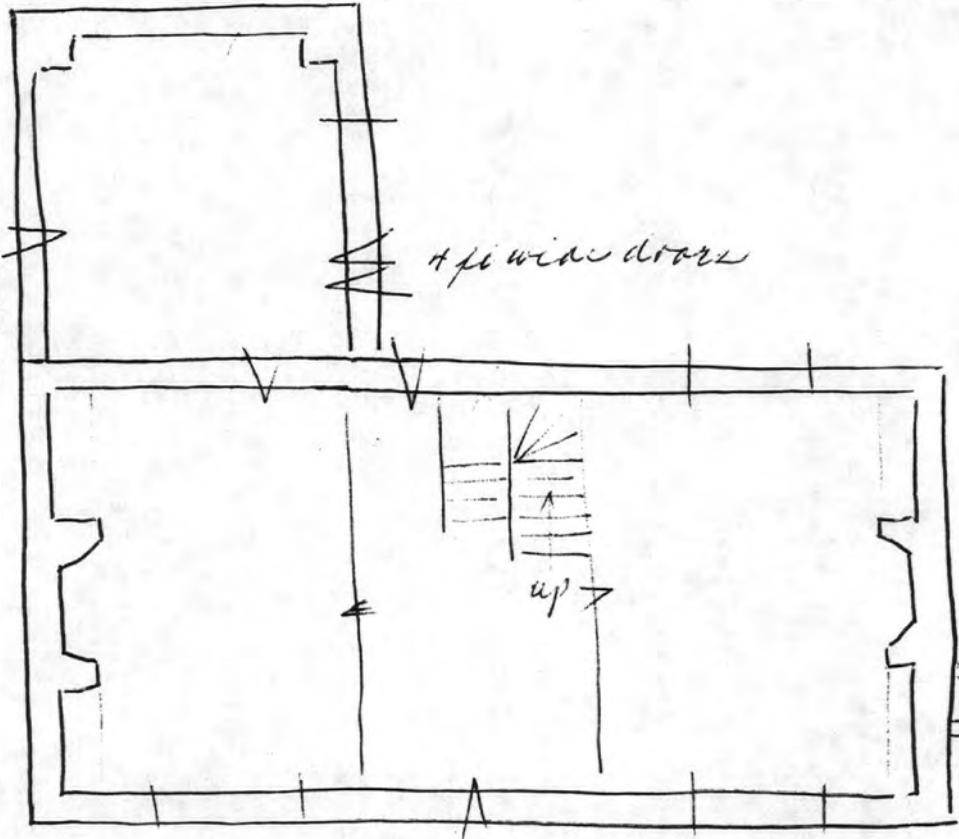
First floor

Center passage has dog leg stair with winder to landing, then straight return (see plan). Lower portion has open stringer, turned balusters and reeded square newell (may have originally been enclosed). Upper run of stair has closed stringer and solid board balustrade. Hall has panelled fire wall with built in presses and cornice. Ovolo window trim.

14 ft opening

to cellar

one window  
each side

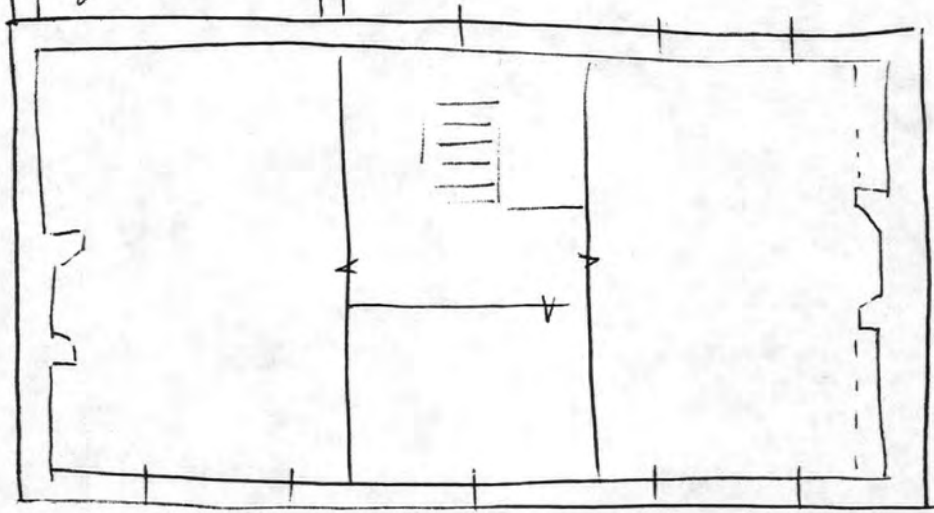
Second floor

End pt  
of kitchen

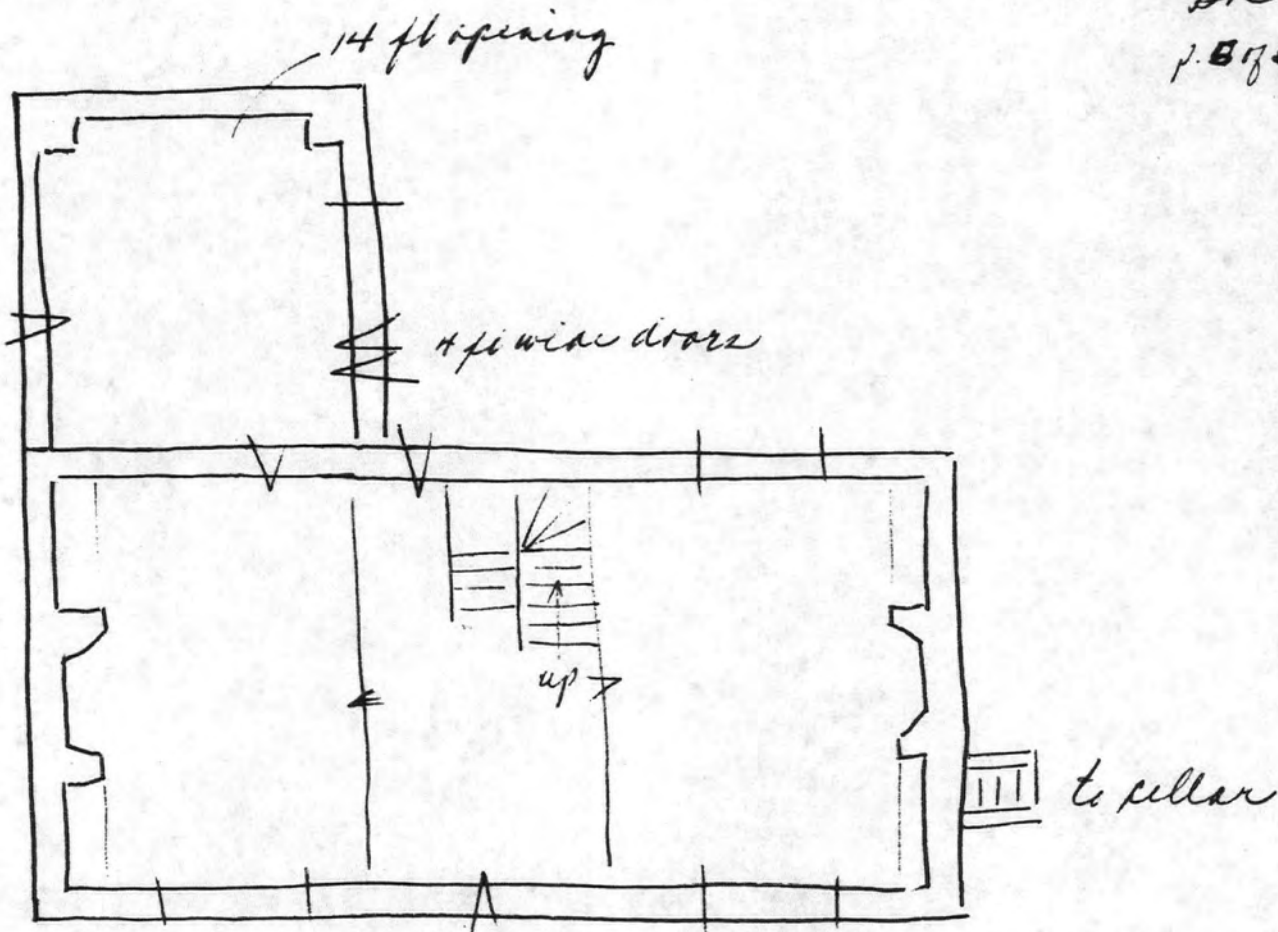
First floor

Center passage has dog-leg stair with winder to landing, then straight return (see plan). Lower portion has open stringer, turned balusters and reeded-square newell (may have originally been enclosed). Upper run of stair has closed stringer and solid board balustrade. Hall has panelled fireplace wall with built-in presses and cornice. Ovolo window trim.

Partition walls between the rooms are framed with vertical 2 x 12 inch planks installed alternately in a board and batten effect, creating a four-inch thick wall, the planks themselves being the wall frame. Horizontal split lathes were fastened directly on the planks. This kind of partition wall is known in New England, but very rare in Kentucky; one other, MS-27, is known.

The kitchen ell abutts, but is not bonded to, the main house. Access from rear of hall, door frames pegged, ovolo trim. Gable end of kitchen contains huge cooking fireplace, 14 foot opening, spanned by a single timber lintel two-feet tall. Only one section of chair rail was put in kitchen, beside window, has 1/2 round nose, no trim; peg rail on east wall. Southwest corner has built-in ladder to garrett, with beaded stringer. Exterior of kitchen has pot log holes on both sides, indicating

one window  
each side

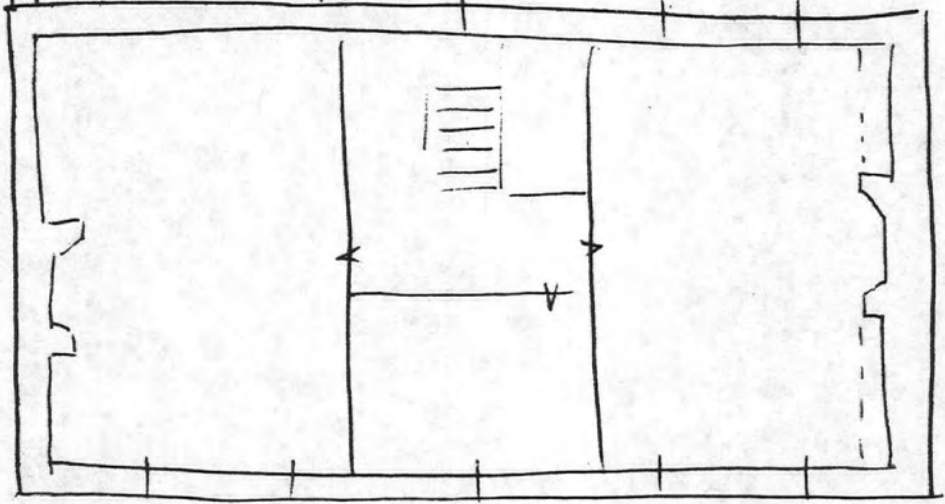
Second floor

2nd fl.  
of kitchen
