KENTUCKY HISTORIC RESOURCES
Individual Inventory Form

Resource # Be-322
Boone County

1. Name of Resource: East Bend Church

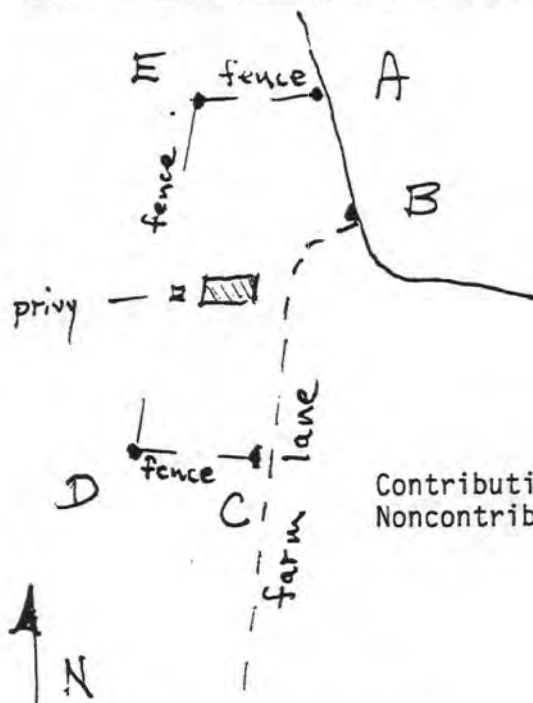
Contributing: 1 building
Noncontributing: 1 building (privy)

The boundary, indicated by points A, B, C, D and E, include the church and privy and the two cemeteries, north and south of the church. The acreage, contained within the fences is sufficient to provide a setting for the church. Boundary A-B is on the west side of Lower River Road, while the boundary B-C is on the west side of a farm lane.

Beginning at a point on the west side of Lower River Road at the east property line (B), proceed 350' south along the lane to the rear property line (C). Then proceed 130' along the fence line to the west property line (D), turning north for 500' along the property and fence line (E). Then proceed east along the fence line to the west side of Lower River Road (A), turning southeast along the road 200' to the point of origin.
